**Flood Control Project Maintenance
Levee Inspections**

Fall 2019 Levee Maintenance Deficiency Summary Report

**Flood Control Project Maintenance
Levee Inspections****LMA District Cover Sheet****Fall 2019 Levee Inspection Results****Sacramento Maintenance Yard Maintenance Area 0004**

Sacramento Maintenance Yard Maintenance Area 0004

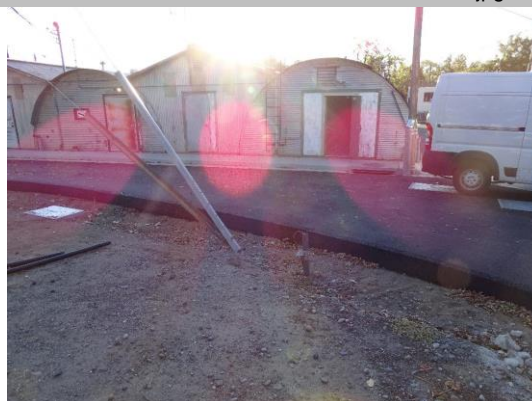
Photo 1 of 3 : UCIP_FA_2019_55304_81541.jpg

LM Start	0.46	Rating **	M	Issue No.	51	
LM End	0.46	Issue Type +	En	Location *		
Category	Supplemental			GPS Latitude/Longitude		
				Start	End	
Item	DRAFT DWR UCIP Field Study			38.599205 °	38.599205 °	
				-121.540303 °	-121.540303 °	
DWR ID	25552					
Comment Code						
Inspector Comment						
DS_ID:25552						
FS_ID:55304						
EP_NO: N/A						
Repair Type: Non-Urgent						
Crossing Status: Not Found						
UCIP Comments: 10/10/2019 According to FMO staff this pipe was disconnected from Sac Yard storm drainage system and grouted in place. (O.Yakimov - DWR UCIP)09/07/2018 Crossing not found (O.Yakimov - DWR UCIP)						
FIELD_STRUCT_DESC: 9-inch steel drainage pipe through the levee, 17.0 feel below levee crown. [Additional Reference(s): USACE Sacramento O&M Manual 116, August 1955, Dwg No. 50-4-4179, page 9 of 19].						
FS Date: 10/10/2019 9:03:15 AM

View of levee crown at potential crossing

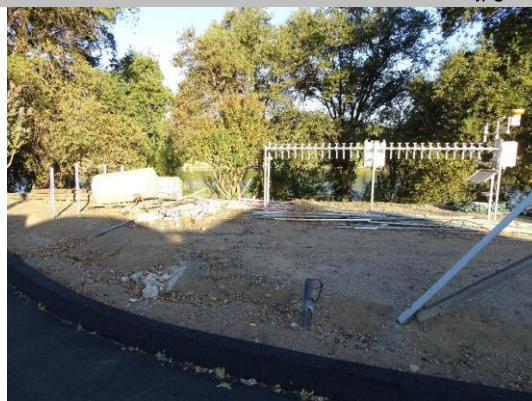
Photo 2 of 3 : UCIP_FA_2019_55304_83345.jpg

LM Start	0.46	Rating **	M	Issue No.	51 (cont)	
LM End	0.46	Issue Type +	En	Location *		
Category	Supplemental			GPS Latitude/Longitude		
				Start	End	
Item	DRAFT DWR UCIP Field Study			38.599205 °	38.599205 °	
				-121.540303 °	-121.540303 °	
DWR ID	25552					
Comment Code						
Inspector Comment						
DS_ID:25552						
FS_ID:55304						
EP_NO: N/A						
Repair Type: Non-Urgent						
Crossing Status: Not Found						
UCIP Comments: 10/10/2019 According to FMO staff this pipe was disconnected from Sac Yard storm drainage system and grouted in place. (O.Yakimov - DWR UCIP)09/07/2018 Crossing not found (O.Yakimov - DWR UCIP)						
FIELD_STRUCT_DESC: 9-inch steel drainage pipe through the levee, 17.0 feel below levee crown. [Additional Reference(s): USACE Sacramento O&M Manual 116, August 1955, Dwg No. 50-4-4179, page 9 of 19].						
FS Date: 10/10/2019 9:03:15 AM

View of levee crown at the crossing

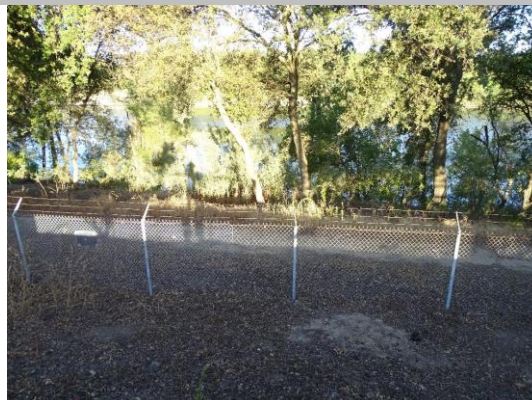
Photo 3 of 3 : UCIP_FA_2019_55304_83346.jpg

View of WS levee slope

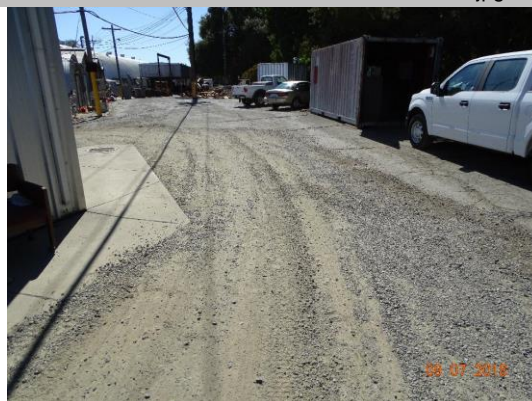
Photo 1 of 3 : UCIP_FA_2019_55305_80008.jpg

LM Start	0.48	Rating **	M	Issue No.	52
LM End	0.48	Issue Type +	En	Location *	
Category	Supplemental			GPS Latitude/Longitude	
				Start	End
Item	DRAFT DWR UCIP Field Study			38.599396 °	38.599396 °
				-121.540026 °	-121.540026 °
DWR ID	25550				
Comment Code					
Inspector Comment					
DS_ID:25550					
FS_ID:55305					
EP_NO: N/A					
Repair Type: Non-Urgent					
Crossing Status: Not Found					
UCIP Comments: 10/10/2019 According to FMO staff this pipe was disconnected from Sac Yard storm drainage system and grouted in place. (O.Yakimov - DWR UCIP)09/07/2018 Crossing not found (O.Yakimov - DWR UCIP)					
FIELD_STRUCT_DESC: 6-inch vitrified clay drainage pipe through the levee, 16.1 feel below levee crown. [Additional Reference(s): USACE Sacramento O&M Manual 116, August 1955), Dwg No. 50-4-4179, page 9 of 19].					
FS Date: 10/10/2019 9:04:32 AM

Top of levee at crossing

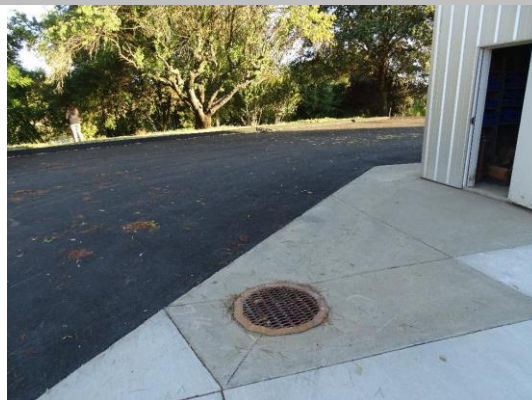
Photo 2 of 3 : UCIP_FA_2019_55305_83347.jpg

View of crown at crossing

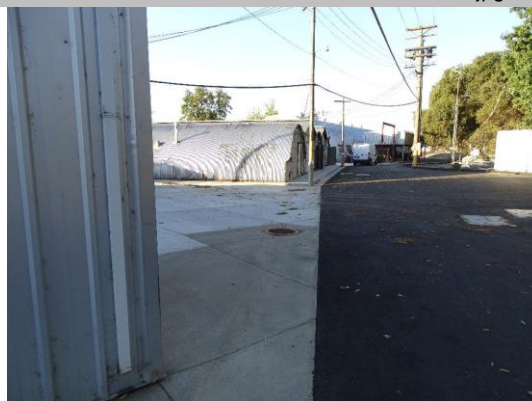
Photo 3 of 3 : UCIP_FA_2019_55305_83348.jpg

LM Start	0.48	Rating **	M	Issue No.	52 (cont)	
LM End	0.48	Issue Type +	En	Location *		
Category	Supplemental			GPS Latitude/Longitude		
				Start	End	
Item	DRAFT DWR UCIP Field Study			38.599396 °	38.599396 °	
				-121.540026 °	-121.540026 °	
DWR ID	25550					
Comment Code						
Inspector Comment						
DS_ID:25550						
FS_ID:55305						
EP_NO: N/A						
Repair Type: Non-Urgent						
Crossing Status: Not Found						
UCIP Comments: 10/10/2019 According to FMO staff this pipe was disconnected from Sac Yard storm drainage system and grouted in place. (O.Yakimov - DWR UCIP)09/07/2018 Crossing not found (O.Yakimov - DWR UCIP)						
FIELD_STRUCT_DESC: 6-inch vitrified clay drainage pipe through the levee, 16.1 feel below levee crown. [Additional Reference(s): USACE Sacramento O&M Manual 116, August 1955), Dwg No. 50-4-4179, page 9 of 19].						
FS Date: 10/10/2019 9:04:32 AM

View of crown at crossing

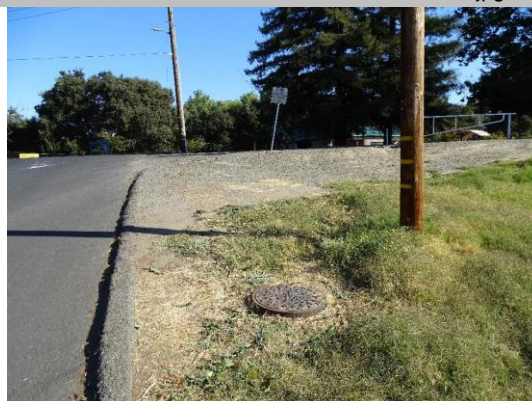
Photo 1 of 3 : UCIP_FA_2019_55300_81531.jpg

LM Start	2.69	Rating **	M	Issue No.	58	
LM End	2.69	Issue Type +	En	Location *		
Category	Supplemental			GPS Latitude/Longitude		
				Start	End	
Item	DRAFT DWR UCIP Field Study			38.590910 °	38.590910 °	
				-121.510830 °	-121.510830 °	
DWR ID	19405					
Comment Code						
Inspector Comment						
DS_ID:19405						
FS_ID:55300						
EP_NO: N/A						
Repair Type: Non-Urgent						
Crossing Status: Found						
UCIP Comments: 10/10/2019 A public restroom on WS and a manhole located on road shoulder may be associated with this crossing.						
(O.Yakimov - DWR UCIP)Found during the field survey, not listed in the desk study.						
FIELD_STRUCT_DESC: 6-inch steel sewer line from the public facility of the boat launching area. No other details available.						
FS Date: 10/10/2019 3:32:36 PM

Manhole on the road shoulder on LS

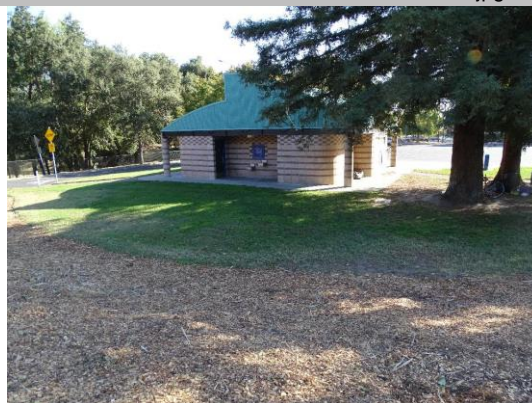
Photo 2 of 3 : UCIP_FA_2019_55300_81532.jpg

Public restroom on WS

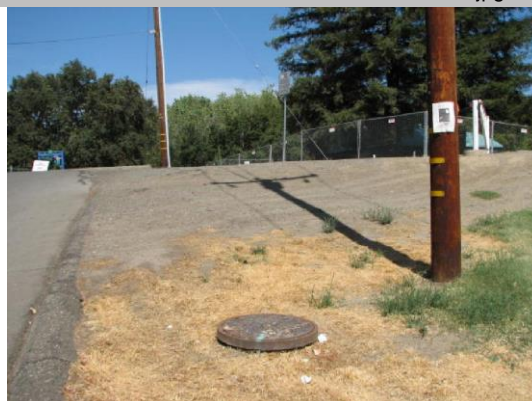
Photo 3 of 3 : UCIP_FA_2019_55300_83349.jpg

LM Start	2.69	Rating **	M	Issue No.	58 (cont)	
LM End	2.69	Issue Type +	En	Location *		
Category	Supplemental			GPS Latitude/Longitude		
				Start	End	
Item	DRAFT DWR UCIP Field Study			38.590910 °	38.590910 °	
				-121.510830 °	-121.510830 °	
DWR ID	19405					
Comment Code						
Inspector Comment						
DS_ID:19405 FS_ID:55300 EP_NO: N/A Repair Type: Non-Urgent Crossing Status: Found UCIP Comments: 10/10/2019 A public restroom on WS and a manhole located on road shoulder may be associated with this crossing. (O.Yakimov - DWR UCIP)Found during the field survey, not listed in the desk study. FIELD_STRUCT_DESC: 6-inch steel sewer line from the public facility of the boat launching area. No other details available. FS Date: 10/10/2019 3:32:36 PM

Older photo of a manhole on the road shoulder on LS

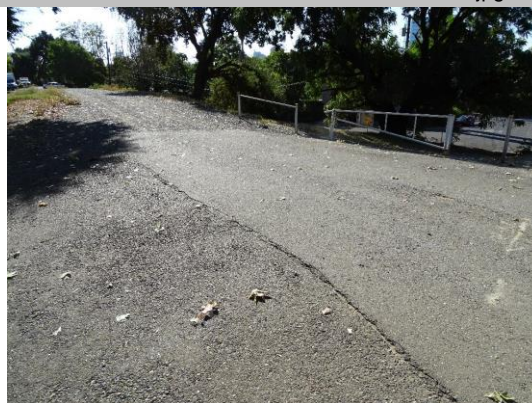
Photo 1 of 3 : UCIP_FA_2019_55310_81562.jpg

LM Start	2.78	Rating **	U	Issue No.	59	
LM End	2.78	Issue Type +	En	Location *		
Category	Supplemental			GPS Latitude/Longitude		
				Start	End	
Item	DRAFT DWR UCIP Field Study			38.590100 °	38.590100 °	
				-121.509693 °	-121.509693 °	
DWR ID	265					
Comment Code						
Inspector Comment						
DS_ID:265 FS_ID:55310 EP_NO: 14527 Repair Type: Urgent Crossing Status: Indicator Found UCIP Comments: 10/10/2019 No maintenance records available for this crossing. (O.Yakimov - DWR UCIP) FIELD_STRUCT_DESC: 12-inch coated steel petroleum pipeline, 3 feet below the crown. Gas/petroleum line markers found on both sides of the levee. (12.75-inch welded steel pipeline authorized under Permit No. 14527, 1987 - Southern Pacific Pipe Lines, Inc.). FS Date: 10/10/2019 10:44:29 AM

View of levee crown at crossing

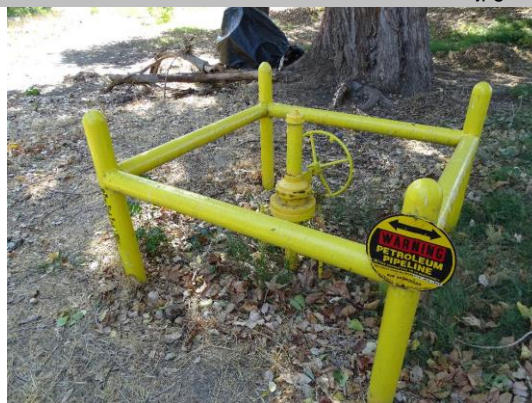
Photo 2 of 3 : UCIP_FA_2019_55310_81564.jpg

LM Start	2.78	Rating **	U	Issue No.	59 (cont)	
LM End	2.78	Issue Type +	En	Location *		
Category	Supplemental			GPS Latitude/Longitude		
				Start	End	
Item	DRAFT DWR UCIP Field Study			38.590100 °	38.590100 °	
				-121.509693 °	-121.509693 °	
DWR ID	265					
Comment Code						
Inspector Comment						
DS_ID:265 FS_ID:55310 EP_NO: 14527 Repair Type: Urgent Crossing Status: Indicator Found UCIP Comments: 10/10/2019 No maintenance records available for this crossing. (O.Yakimov - DWR UCIP) FIELD_STRUCT_DESC: 12-inch coated steel petroleum pipeline, 3 feet below the crown. Gas/petroleum line markers found on both sides of the levee. (12.75-inch welded steel pipeline authorized under Permit No. 14527, 1987 - Southern Pacific Pipe Lines, Inc.). FS Date: 10/10/2019 10:44:29 AM

Petroleum line marker on WS

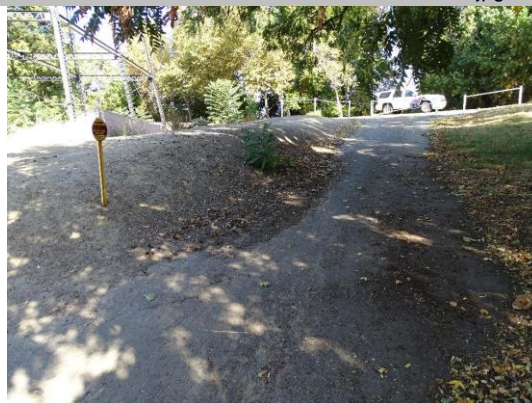
Photo 3 of 3 : UCIP_FA_2019_55310_81565.jpg

Petroleum line marker and ramp on LS

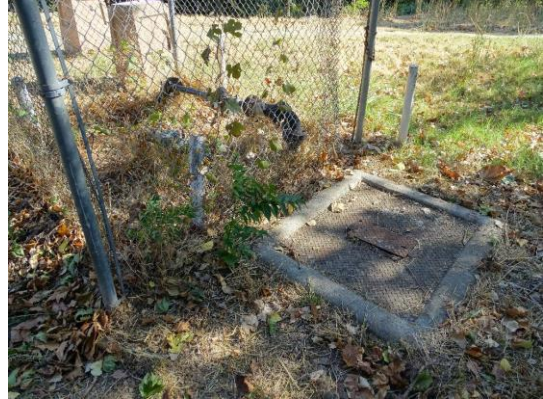
Photo 1 of 3 : UCIP_FA_2019_55311_81566.jpg

LM Start	2.78	Rating **	M	Issue No.	60
LM End	2.78	Issue Type +	En	Location *	
Category	Supplemental			GPS Latitude/Longitude	
				Start	End
Item	DRAFT DWR UCIP Field Study			38.590111 °	38.590111 °
				-121.509695 °	-121.509695 °
DWR ID	19406				
Comment Code					
Inspector Comment					
DS_ID:19406 FS_ID:55311 EP_NO: N/A Repair Type: Non-Urgent Crossing Status: Found UCIP Comments: 10/10/2019 Missing permit for this crossing. (O.Yakimov - DWR UCIP)Found during field survey. Not listed in the desk study. FIELD_STRUCT_DESC: 1 of 2: 3-inch wrapped galvanized iron (GI) water pipe through the levee, at an unknown depth. Pipe daylights in a metal cage box. Valve box for the pipe is also found. FS Date: 10/10/2019 11:45:35 AM

Waterside view: a control valve box with a metal lid

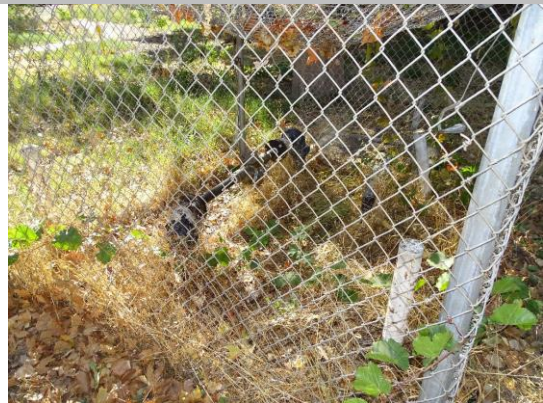
Photo 2 of 3 : UCIP_FA_2019_55311_81567.jpg

Waterside view: pipe daylights in a metal cage

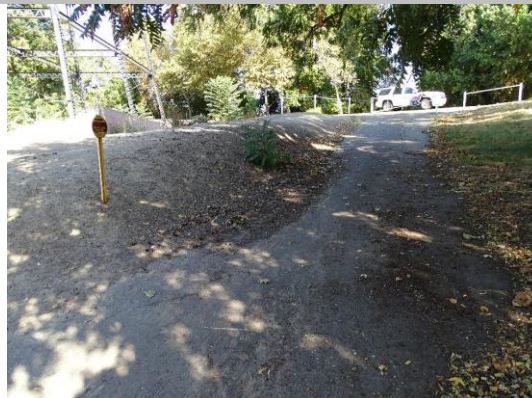
Photo 3 of 3 : UCIP_FA_2019_55311_81568.jpg

LM Start	2.78	Rating **	M	Issue No.	60 (cont)	
LM End	2.78	Issue Type +	En	Location *		
Category	Supplemental			GPS Latitude/Longitude		
				Start	End	
Item	DRAFT DWR UCIP Field Study			38.590111 °	38.590111 °	
				-121.509695 °	-121.509695 °	
DWR ID	19406					
Comment Code						
Inspector Comment						
DS_ID:19406 FS_ID:55311 EP_NO: N/A Repair Type: Non-Urgent Crossing Status: Found UCIP Comments: 10/10/2019 Missing permit for this crossing. (O.Yakimov - DWR UCIP)Found during field survey. Not listed in the desk study. FIELD_STRUCT_DESC: 1 of 2: 3-inch wrapped galvanized iron (GI) water pipe through the levee, at an unknown depth. Pipe daylights in a metal cage box. Valve box for the pipe is also found. FS Date: 10/10/2019 11:45:35 AM

View of landside at the crossing

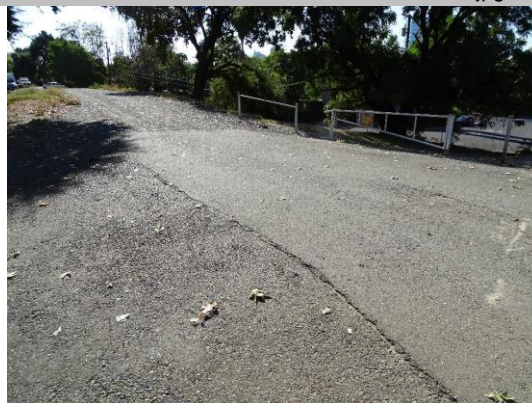
Photo 1 of 3 : UCIP_FA_2019_55312_81569.jpg

LM Start	2.78	Rating **	M	Issue No.	61
LM End	2.78	Issue Type +	En	Location *	
Category	Supplemental			GPS Latitude/Longitude	
				Start	End
Item	DRAFT DWR UCIP Field Study			38.590105 °	38.590105 °
				-121.509687 °	-121.509687 °
DWR ID	19407				
Comment Code					
Inspector Comment					
DS_ID:19407 FS_ID:55312 EP_NO: N/A Repair Type: Non-Urgent Crossing Status: Found UCIP Comments: 10/10/2019 Missing permit for this crossing. (O.Yakimov - DWR UCIP) Found during field survey, not listed in the desk study. FIELD_STRUCT_DESC: 2 of 2: 5-inch wrapped galvanized iron (GI) water pipe through the levee, at an unknown depth. Pipe daylights in a metal cage box. Valve box for the pipe is also found. FS Date: 10/10/2019 11:57:04 AM

Levee crown at the crossing

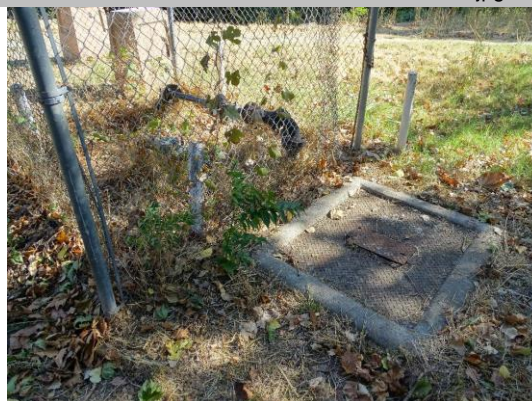
Photo 2 of 3 : UCIP_FA_2019_55312_81570.jpg

LM Start	2.78	Rating **	M	Issue No.	61 (cont)	
LM End	2.78	Issue Type +	En	Location *		
Category	Supplemental			GPS Latitude/Longitude		
				Start	End	
Item	DRAFT DWR UCIP Field Study			38.590105 °	38.590105 °	
				-121.509687 °	-121.509687 °	
DWR ID	19407					
Comment Code						
Inspector Comment						
DS_ID:19407						
FS_ID:55312						
EP_NO: N/A						
Repair Type: Non-Urgent						
Crossing Status: Found						
UCIP Comments: 10/10/2019 Missing permit for this crossing.						
(O.Yakimov - DWR UCIP)						
Found during field survey, not listed in the desk study.						
FIELD_STRUCT_DESC: 2 of 2: 5-inch wrapped galvanized iron (GI)						
water pipe through the levee, at an unknown depth. Pipe daylights in a						
metal cage box. Valve box for the pipe is also found.						
FS Date: 10/10/2019 11:57:04 AM

Waterside view: a control valve box with a metal lid

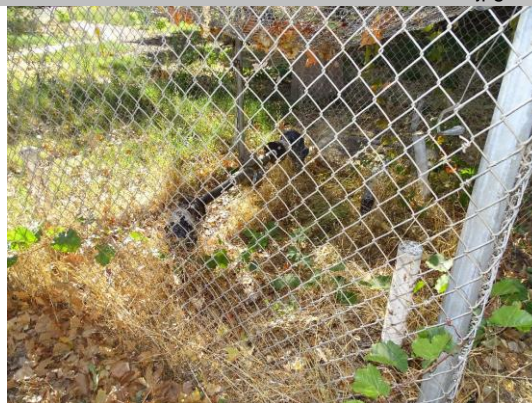
Photo 3 of 3 : UCIP_FA_2019_55312_81571.jpg

Waterside view: pipe daylights in a metal cage

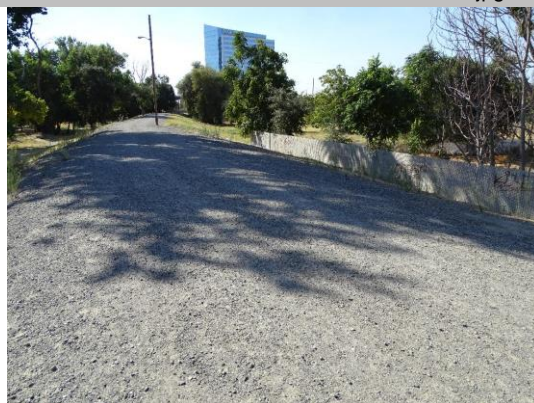
Photo 1 of 3 : UCIP_FA_2019_55314_81572.jpg

Comment Code					
Inspector Comment					
DS_ID:18886 FS_ID:55314 EP_NO: N/A Repair Type: Non-Urgent Crossing Status: Found UCIP Comments: 10/10/2019 Pipe end is visible on river's edge. Homeless people installed camping tents nearby. (O.Yakimov - DWR UCIP)Grouted 10-inch pipe on water side of the levee. FIELD_STRUCT_DESC: *ABANDONED* 4 of 4: 10-inch pipe of an unknown material or purpose through the levee, 18.6 feet below the crown. Unable to locate. Pipe exposed and extends 10 feet from the bank and 5 feet above current water surface. Needs to be removed or grouted. [Additional Reference(s): DWR Levee Log, 2005. USACE Sacramento O&M Manual 116, August 1955, (RM 59.65)]. FS Date: 10/10/2019 1:17:20 PM

View of levee crown at crossing

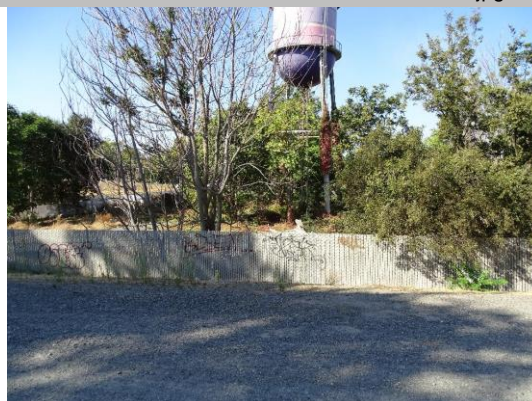
Photo 2 of 3 : UCIP_FA_2019_55314_81574.jpg

Comment Code						
Inspector Comment						
DS_ID:18886 FS_ID:55314 EP_NO: N/A Repair Type: Non-Urgent Crossing Status: Found UCIP Comments: 10/10/2019 Pipe end is visible on river's edge. Homeless people installed camping tents nearby. (O.Yakimov - DWR UCIP)Grouted 10-inch pipe on water side of the levee. FIELD_STRUCT_DESC: *ABANDONED* 4 of 4: 10-inch pipe of an unknown material or purpose through the levee, 18.6 feet below the crown. Unable to locate. Pipe exposed and extends 10 feet from the bank and 5 feet above current water surface. Needs to be removed or grouted. [Additional Reference(s): DWR Levee Log, 2005. USACE Sacramento O&M Manual 116, August 1955, (RM 59.65)]. FS Date: 10/10/2019 1:17:20 PM

Land side view- inside water tower area

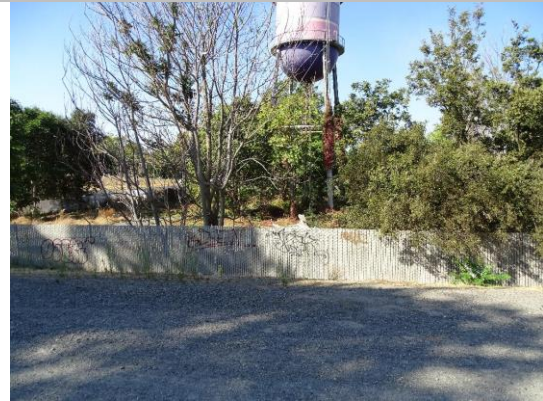
Photo 1 of 3 : UCIP_FA_2019_55315_81576.jpg

Comment Code						
Inspector Comment						
DS_ID:18883 FS_ID:55315 EP_NO: N/A Repair Type: Non-Urgent Crossing Status: Found UCIP Comments: 10/10/2019 Abandoned pipe, no permit available. (DWR - UCIP O.Yakimov)Abandoned 7-inch pipe found. Needs to be abandoned properly. FIELD_STRUCT_DESC: *ABANDONED* 2 of 4: 7-inch pipe of an unknown material or purpose through the levee, 18.6 feet below the crown. Unable to locate. Pipe exposed and extends 10 feet from the bank and 5 feet above current water surface. Needs to be removed or grouted. [Additional Reference(s): DWR Levee Log, 2005. USACE Sacramento O&M Manual 116, August 1955, (RM 59.65)]. FS Date: 10/10/2019 1:49:06 PM

Land side view: water tower area

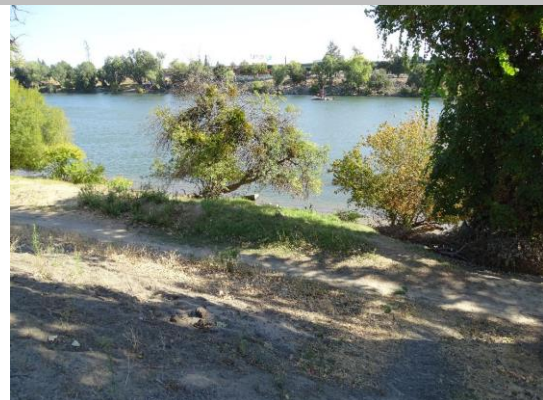
Photo 2 of 3 : UCIP_FA_2019_55315_81577.jpg

Overview of waterside at pipe crossing

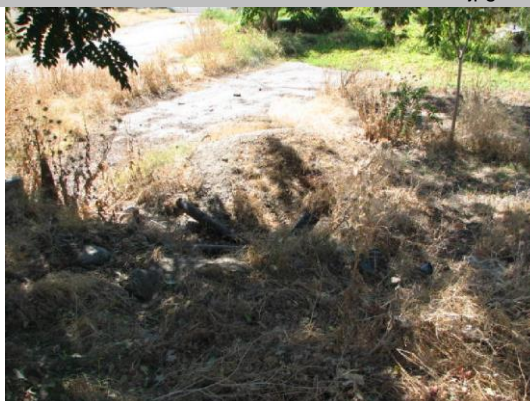
Photo 3 of 3 : UCIP_FA_2019_55315_9770.jpg

Comment Code						
Inspector Comment						
DS_ID:18883 FS_ID:55315 EP_NO: N/A Repair Type: Non-Urgent Crossing Status: Found UCIP Comments: 10/10/2019 Abandoned pipe, no permit available. (DWR - UCIP O.Yakimov)Abandoned 7-inch pipe found. Needs to be abandoned properly. FIELD_STRUCT_DESC: *ABANDONED* 2 of 4: 7-inch pipe of an unknown material or purpose through the levee, 18.6 feet below the crown. Unable to locate. Pipe exposed and extends 10 feet from the bank and 5 feet above current water surface. Needs to be removed or grouted. [Additional Reference(s): DWR Levee Log, 2005. USACE Sacramento O&M Manual 116, August 1955, (RM 59.65)]. FS Date: 10/10/2019 1:49:06 PM

Land side view- abandoned pipes inside the tower area

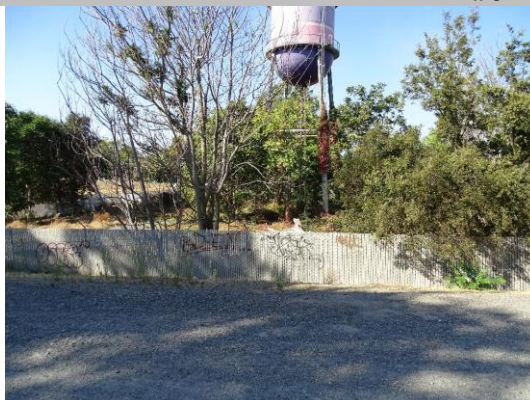
Photo 1 of 3 : UCIP_FA_2019_55316_81578.jpg

LM Start	2.93	Rating **	M	Issue No.	65	
LM End	2.93	Issue Type +	En	Location *		
Category	Supplemental			GPS Latitude/Longitude		
				Start		End
Item	DRAFT DWR UCIP Field Study			38.588688 °		38.588688 °
				-121.507910 °		-121.507910 °
DWR ID	18885					
Comment Code						
Inspector Comment						
DS_ID:18885 FS_ID:55316 EP_NO: N/A Repair Type: Non-Urgent Crossing Status: Found UCIP Comments: 10/10/2019 Abandoned pipe, no permit available. (DWR - UCIP O.Yakimov) FIELD_STRUCT_DESC: *ABANDONED* 3 of 4: 7-inch pipe of an unknown material or purpose through the levee, 18.6 feet below the crown. Unable to locate. Pipe exposed and extends 10 feet from the bank and 5 feet above current water surface. Needs to be removed or grouted. [Additional Reference(s): DWR Levee Log, 2005. USACE Sacramento O&M Manual 116, August 1955, (RM 59.65)]. FS Date: 10/10/2019 2:12:14 PM

Land side view: water tower area

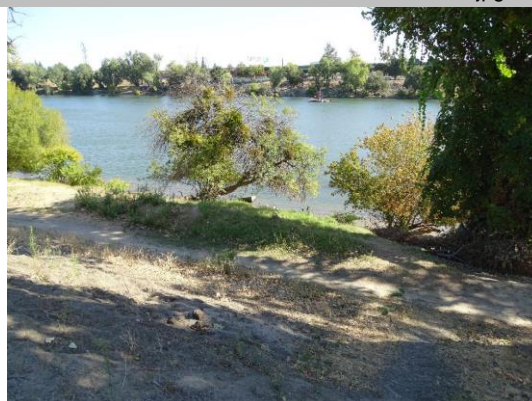
Photo 2 of 3 : UCIP_FA_2019_55316_81579.jpg

LM Start	2.93	Rating **	M	Issue No.	65 (cont)	
LM End	2.93	Issue Type +	En	Location *		
Category	Supplemental			GPS Latitude/Longitude		
				Start	End	
Item	DRAFT DWR UCIP Field Study			38.588688 °	38.588688 °	
				-121.507910 °	-121.507910 °	
DWR ID	18885					
Comment Code						
Inspector Comment						
DS_ID:18885 FS_ID:55316 EP_NO: N/A Repair Type: Non-Urgent Crossing Status: Found UCIP Comments: 10/10/2019 Abandoned pipe, no permit available. (DWR - UCIP O.Yakimov) FIELD_STRUCT_DESC: *ABANDONED* 3 of 4: 7-inch pipe of an unknown material or purpose through the levee, 18.6 feet below the crown. Unable to locate. Pipe exposed and extends 10 feet from the bank and 5 feet above current water surface. Needs to be removed or grouted. [Additional Reference(s): DWR Levee Log, 2005. USACE Sacramento O&M Manual 116, August 1955, (RM 59.65)]. FS Date: 10/10/2019 2:12:14 PM

Overview of waterside at pipe crossing

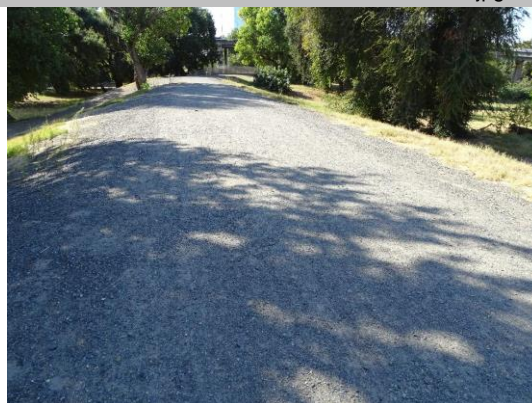
Photo 1 of 3 : UCIP_FA_2019_55317_81581.jpg

Item	DRAFT DWR UCIP Field Study		38.587760 °	38.587760 °								
			-121.507930 °	-121.507930 °								
DWR ID	266											
Comment Code												
Inspector Comment												
DS_ID:266 FS_ID:55317 EP_NO: 16702 Repair Type: Non-Urgent Crossing Status: Not Found UCIP Comments: 10/10/2019 Crossing not found (O.Yakimov - DWR UCIP) FIELD_STRUCT_DESC: 4.5-inch polyvinyl chloride (PVC) irrigation pipe through the levee, 2 feet below the crown. Public facilities and four stairways on the levee slope. Observation/fishing dock on the waterside (WS) of the levee. (4-inch irrigation pipe and 1-inch potable water main line authorized under Permit No. 16702, 1997 - City of West Sacramento). FS Date: 10/10/2019 2:36:29 PM

View of levee crown at possible crossing

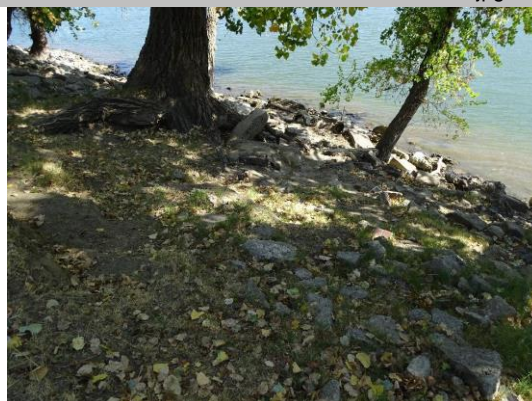
Photo 2 of 3 : UCIP_FA_2019_55317_81582.jpg

LM Start	2.99	Rating **	M	Issue No.	66 (cont)	
LM End	2.99	Issue Type +	En	Location *		
Category	Supplemental			GPS Latitude/Longitude		
				Start	End	
Item	DRAFT DWR UCIP Field Study			38.587760 °	38.587760 °	
				-121.507930 °	-121.507930 °	
DWR ID	266					
Comment Code						
Inspector Comment						
DS_ID:266 FS_ID:55317 EP_NO: 16702 Repair Type: Non-Urgent Crossing Status: Not Found UCIP Comments: 10/10/2019 Crossing not found (O.Yakimov - DWR UCIP) FIELD_STRUCT_DESC: 4.5-inch polyvinyl chloride (PVC) irrigation pipe through the levee, 2 feet below the crown. Public facilities and four stairways on the levee slope. Observation/fishing dock on the waterside (WS) of the levee. (4-inch irrigation pipe and 1-inch potable water main line authorized under Permit No. 16702, 1997 - City of West Sacramento). FS Date: 10/10/2019 2:36:29 PM

Riverbank near possible crossing

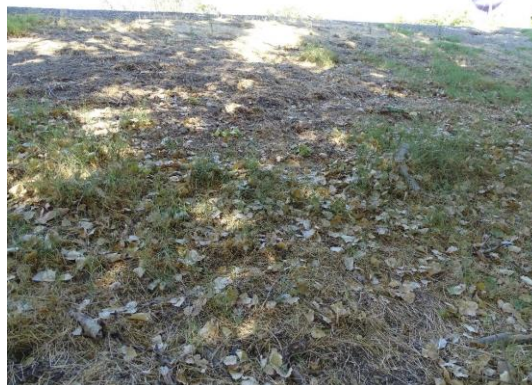
Photo 3 of 3 : UCIP_FA_2019_55317_81583.jpg

View of WS slope at possible crossing

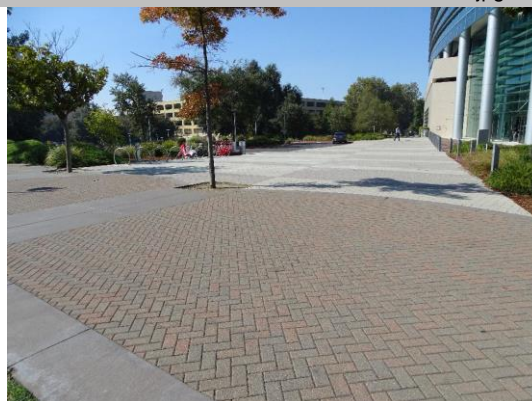
Photo 1 of 1 : UCIP_FA_2019_55346_81587.jpg

LM Start	3.20	Rating **	M	Issue No.	67	
LM End	3.20	Issue Type +	En	Location *		
Category	Supplemental			GPS Latitude/Longitude		
				Start	End	
Item	DRAFT DWR UCIP Field Study			38.584860 °	38.584860 °	
				-121.508500 °	-121.508500 °	
DWR ID	268					
Comment Code						
Inspector Comment						
DS_ID:268						
FS_ID:55346						
EP_NO: 17058						
Repair Type: Non-Urgent						
Crossing Status: Not Found						
UCIP Comments: 10/10/2019 Crossing not found (O.Yakimov - DWR UCIP)						
FIELD_STRUCT_DESC: Three 2-inch and two 1.5-inch fiber optics conduits of an unknown material across and bored under the Sacramento River and its west levee. Note in permit indicates this was not installed.						
FS Date: 10/10/2019 1:36:42 PM

Paved levee crown at possible crossing

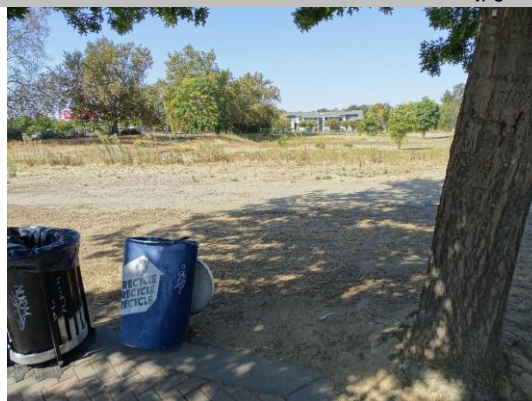
Photo 1 of 2 : UCIP_FA_2019_55349_81591.jpg

LM Start	3.42	Rating **	M	Issue No.	68
LM End	3.42	Issue Type +	En	Location *	
Category	Supplemental			GPS Latitude/Longitude	
				Start	End
Item	DRAFT DWR UCIP Field Study			38.581697 °	38.581697 °
				-121.509358 °	-121.509358 °
DWR ID	271				
Comment Code					
Inspector Comment					
DS_ID:271 FS_ID:55349 EP_NO: 16702 Repair Type: Non-Urgent Crossing Status: Not Found UCIP Comments: 10/10/2019 Crossing not found (O.Yakimov - DWR UCIP) FIELD_STRUCT_DESC: 4.5-inch polyvinyl chloride (PVC) irrigation pipe through the levee, 2 feet below the crown. Public facilities and four stairways on the levee slope. Observation/fishing dock on the waterside (WS). (4-inch irrigation pipe and 1-inch potable water main line authorized under Permit No. 16702, 1997 - City of West Sacramento). FS Date: 10/10/2019 1:54:14 PM

View of LS at potential crossing

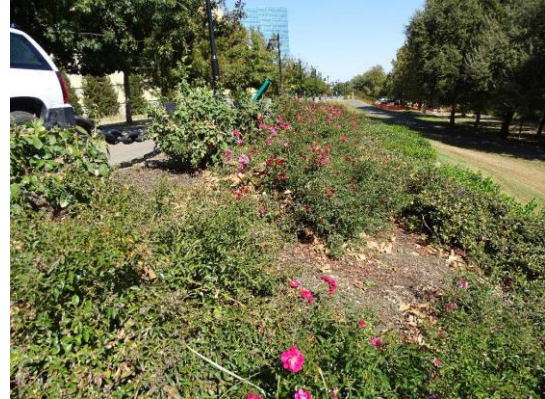
Photo 2 of 2 : UCIP_FA_2019_55349_81592.jpg

LM Start	3.42	Rating **	M	Issue No.	68 (cont)	
LM End	3.42	Issue Type +	En	Location *		
Category	Supplemental			GPS Latitude/Longitude		
				Start	End	
Item	DRAFT DWR UCIP Field Study			38.581697 °	38.581697 °	
				-121.509358 °	-121.509358 °	
DWR ID	271					
Comment Code						
Inspector Comment						
DS_ID:271 FS_ID:55349 EP_NO: 16702 Repair Type: Non-Urgent Crossing Status: Not Found UCIP Comments: 10/10/2019 Crossing not found (O.Yakimov - DWR UCIP) FIELD_STRUCT_DESC: 4.5-inch polyvinyl chloride (PVC) irrigation pipe through the levee, 2 feet below the crown. Public facilities and four stairways on the levee slope. Observation/fishing dock on the waterside (WS). (4-inch irrigation pipe and 1-inch potable water main line authorized under Permit No. 16702, 1997 - City of West Sacramento). FS Date: 10/10/2019 1:54:14 PM

View of WS slope at potential crossing
